# **Clark County Unit Resource Analysis**

## **Step Two: Inventory Data**

CLARK COUNTY RANGE IMPROVEMENT INVENTORY, SPRING 1979  
STATELINE RESOURCE AREA

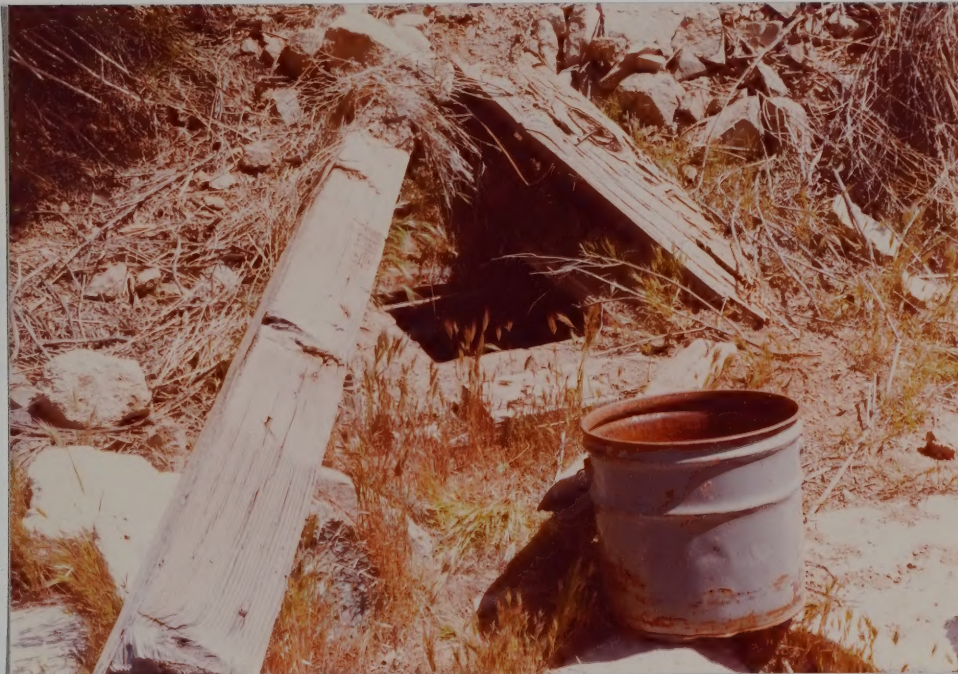
WATER INVENTORY WRITEUP#/URA OVERLAY KEY #: 654

LOCATION T 31S R 65E SEC. 4 NW

DATE PHOTO TAKEN: 4-19-79

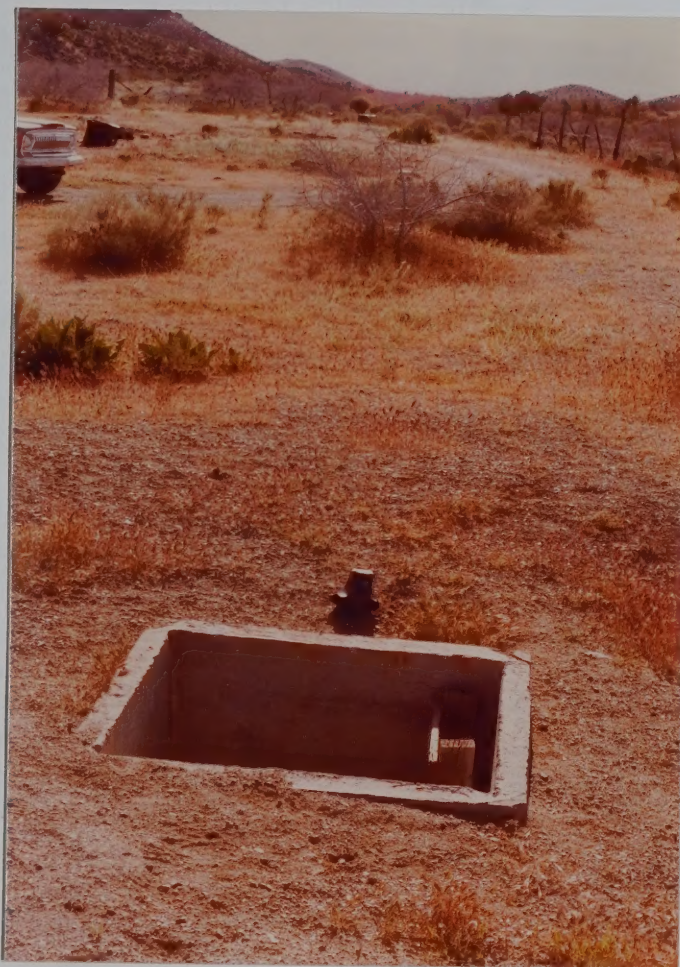
LOCATION T31S R65E S22.8 SW/NW

DATE PHOTO TAKEN: 4-19-79

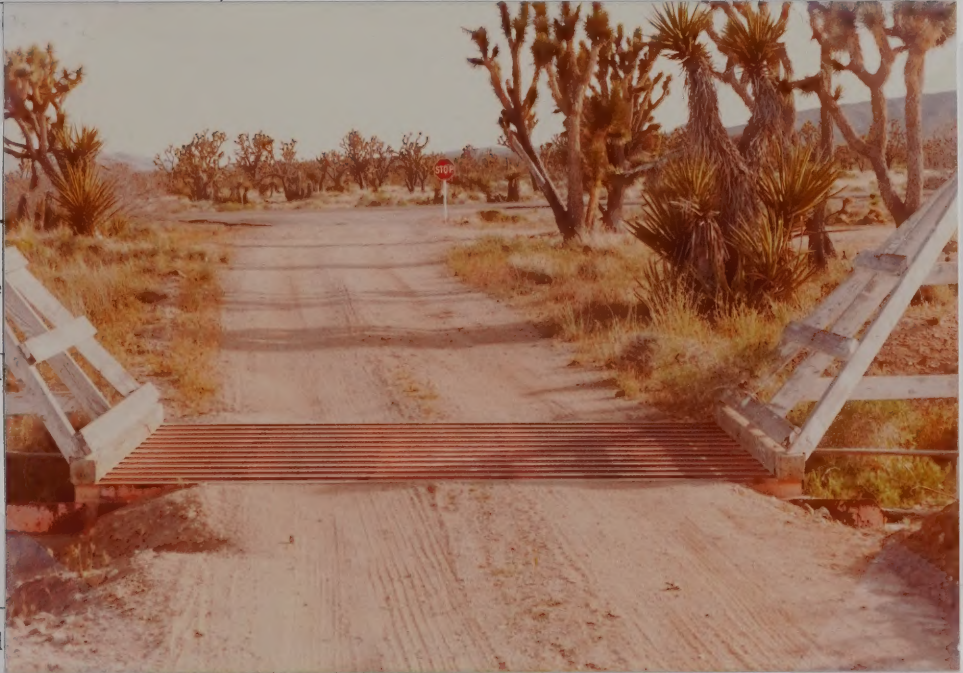
| 5. Location<br><u>T. 27S., R. 63E., Sec. 10, 1/4 Sec. SE</u> | | | 6. Type of improvement<br><u>Cattleguard</u> |
| 7a. Last inspection (date) | | | b. Condition or success of improvement<br><input checked="" type="checkbox"/> good <input type="checkbox"/> fair <input type="checkbox"/> poor <input type="checkbox"/> failure |

| 8a. Recommended action<br><input checked="" type="checkbox"/> Normal maintenance<br><input type="checkbox"/> Abandon | |
